ABC PULP & PAPER COMPANY
ANY TOWN, ANYWHERE

REPORT of NON-DESTRUCTIVE INSPECTION
W. I. P. INSPECTION OF GENERATING BANK TUBES
POWER BOILER

MAY 2002

Re : Final Report on W. I. P. Ultrasonic Inspection of Power Boiler Generating Bank (full-length Mud Drum to Steam Drum) Tubes - May 2002.

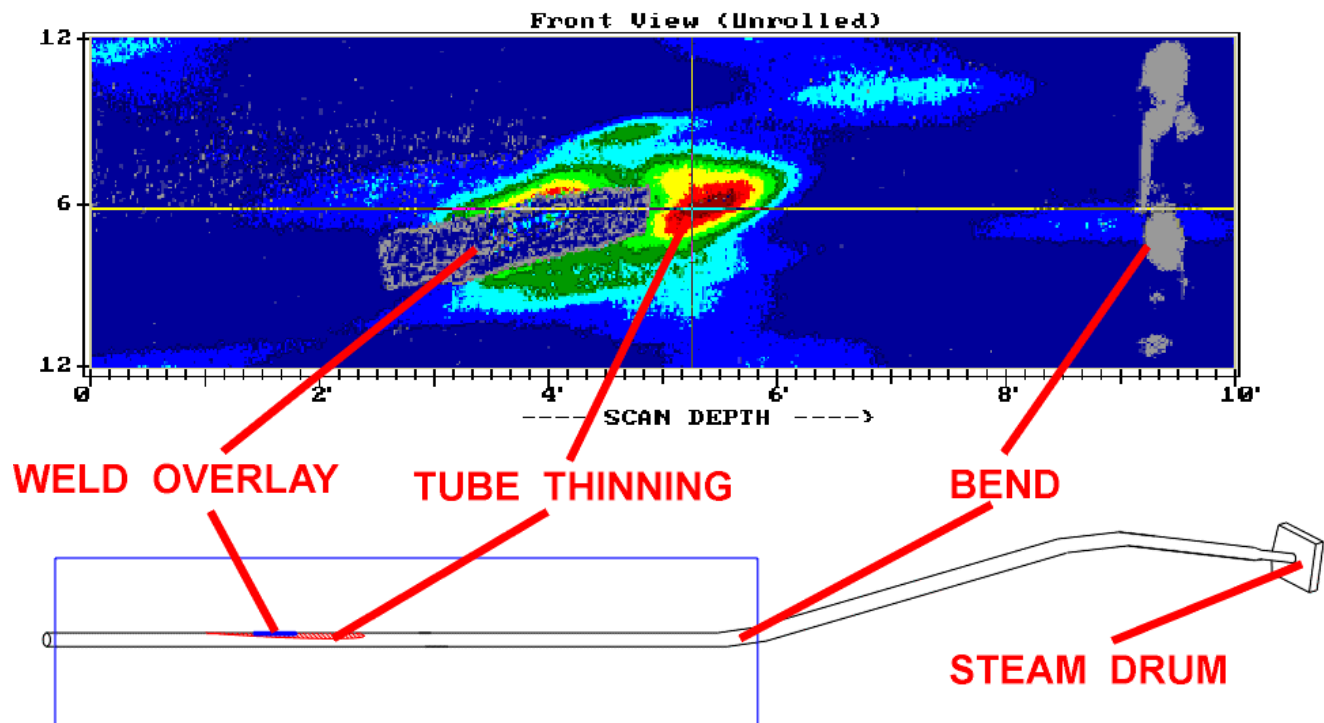
- (1) From the WIP inspection of the sample of generating bank tube inspected, we can conclude that the tube thinning is occurring in the following locations in the generating bank:-
 - a) In the central sootblower lanes on both the "Hot" and "Cold" sides in areas near and/or around the previous weld overlay areas – as typified by the C-scan image below. See also the "visualisation" sketches attached for both the "Lower" and "Upper" sootblower locations. The mechanism for the tube thinning is probably the action of the sootblower eroding the tubes at these sootblower (IK lane) locations. The attached sample WIP images, in the "Sample Images" section, T05R01 "B" on the "Cold" side; T06R014 "B", T67R14 "B" and T68R14 "B" on the "Hot" side, show the tube thinning at these locations.

C-Scan Image of T05R01 "B" Cold Side showing typical tube thinning near a weld overlay

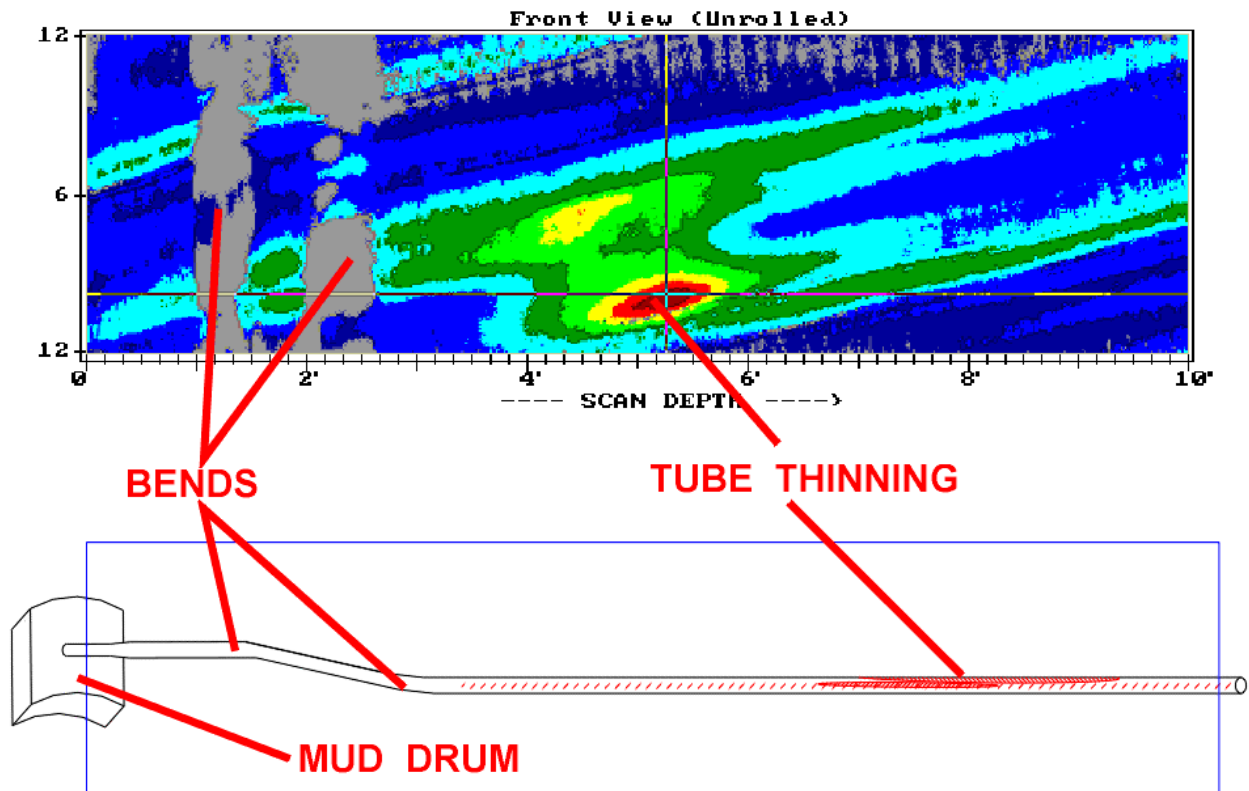
- b) On the tubes in Rows next to the central sootblower (ie. Rows 13, 12 and 11 on the “Hot” side; and Rows 02 and 03 on the “Cold” side). The two C-scans below illustrate this, highlighting the erosive action of the central sootblower on the “inner” tubes. This type of thinning is typified by the attached WIP images T05R13 “A” and T05R02 “A”.

C-Scan Image of T05R13 “A” Hot Side showing area of typical tube thinning

A total of 400 tubes were inspected of which five tubes were found to be below the "allowable" code minimum set at 0.100" on the "Hot" side and 0.115" on the "Cold" side . T05R13, T06R11, T06R12, T06R13 on the "Hot" side and T05R02 on the "Cold" side are to be plugged. T05R14, T06R14, T07R14, T67R14 and T68R14 on the "Hot" side are accessible and hence will be overlay before putting the boiler back in service again.

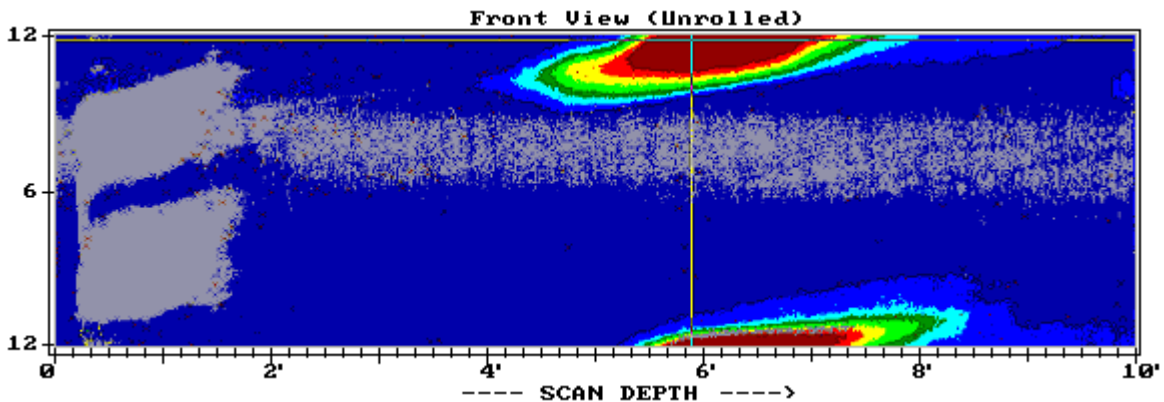
C-Scan Image of T05R02 “A” Cold Side showing area of typical tube thinning

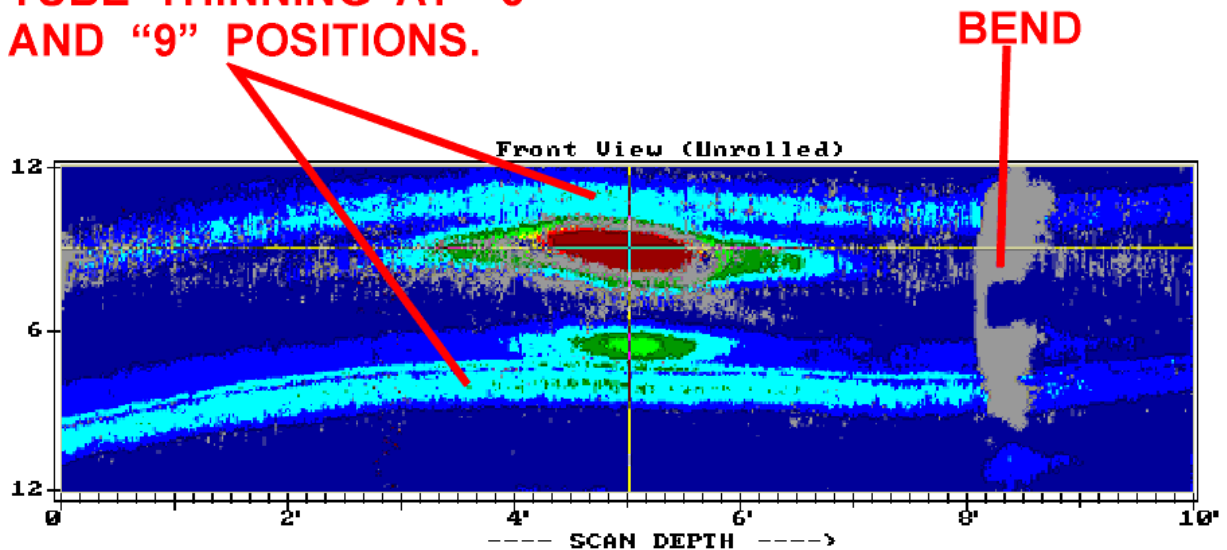
- c) On almost all the tubes inspected in the “Hot” side had tube thinning on the sides of the tubes at the “3” and “9” o'clock position. The C-scan image below shows the tube thinning at “3” and “9” o'clock positions in addition to the thinning due to the central sootblower. This is shown in the “visualisation” sketch for the front tubes, where the flue gas passes in between the tube causing tube thinning on the sides of the tubes at “3” and “9” o'clock. The attached WIP images, in the “sample Images” section, T04R12 “A”, T06R12 “B”, T06R13 “A”, T05R13 “A”, T06R14 “B”, T67R14 “B”, T68R14 “B” “Hot” side exhibit this type of tube thinning.

[C-Scan Image of T06R12 “B” Hot Side showing tube thinning at “3” and “9” o'clock positions](#)

TUBE THINNING AT “3” AND “9” POSITIONS.

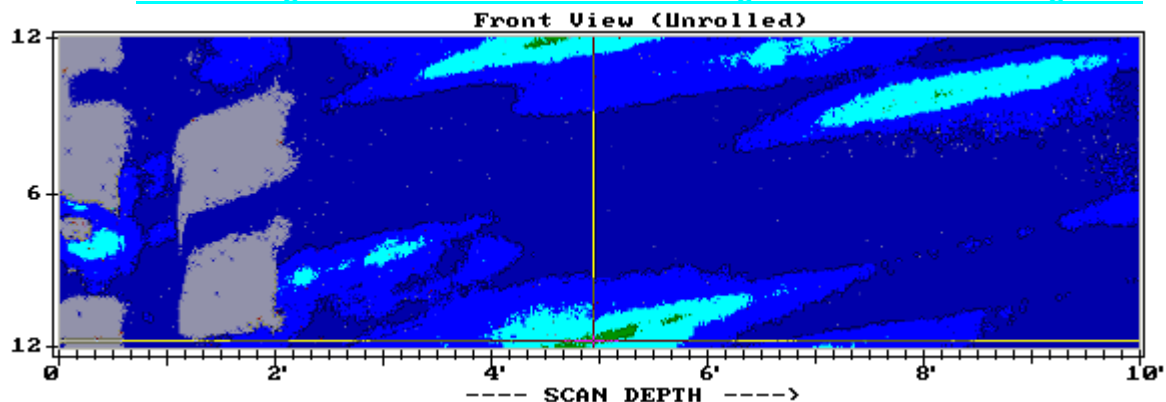
- d) On first few rows on the “Cold” side next to the central sootblower lane, the tube exhibits “random” thinning as shown in the C-scan image below. This could be attributed to the turbulence caused by both the sootblower and the flue gas from the “Hot” side.

[C-Scan Image of T24R04 “A” Cold Side showing “random” tube thinning areas](#)

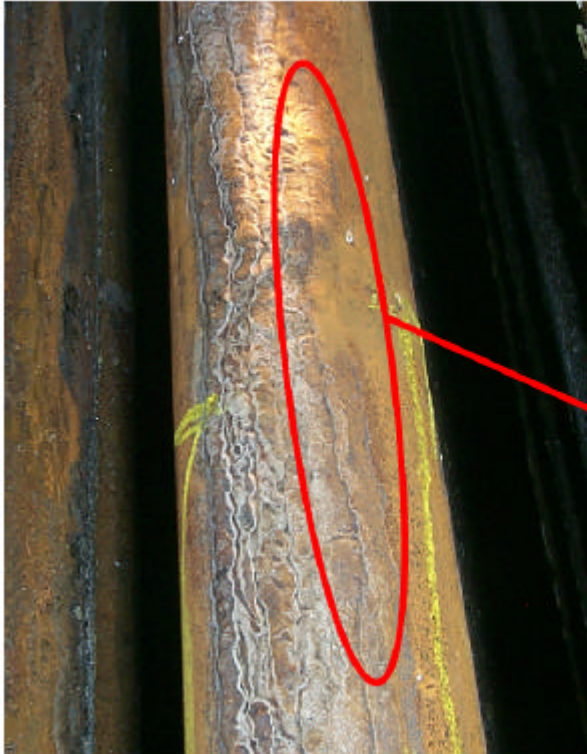
Pictures and C-Scan Image showing overlay areas in T06R14 "Hot" Side upper sootblower

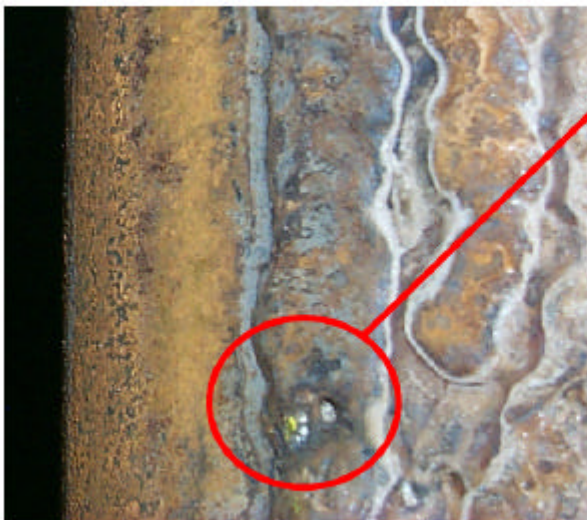
Low Area "missed" by Overlay

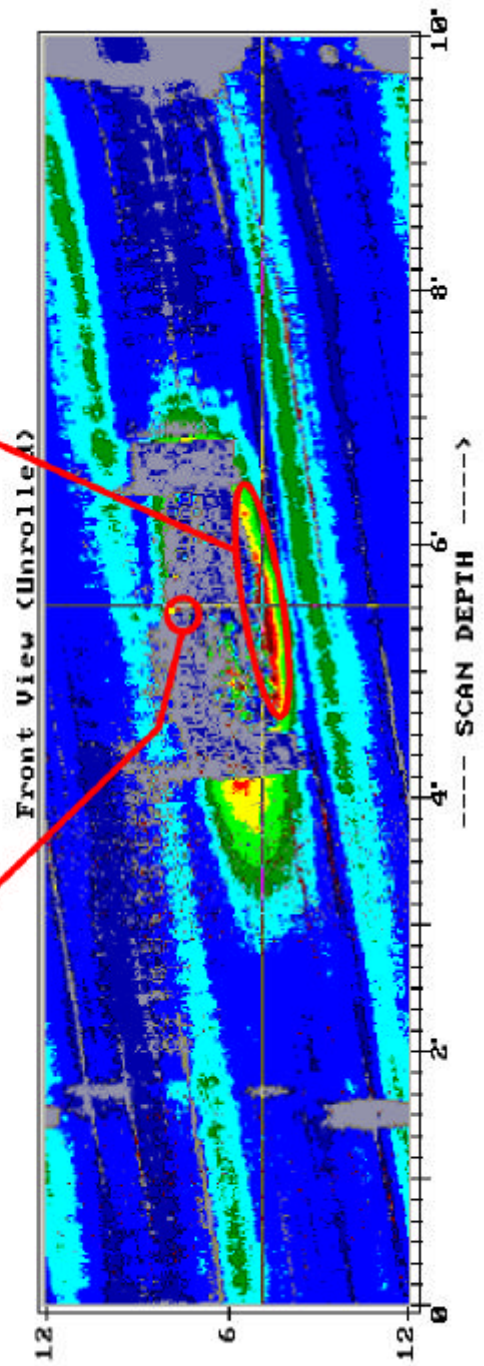
Close-up of Large "Pit" in Overlay
