1-E CAUSTIC PRE-HEATERS

JANUARY 2002

**REPORT of NON-DESTRUCTIVE INSPECTION**  
**W. I. P. ULTRASONIC INSPECTION OF HEAT EXCHANGER TUBES**  
**1-E CAUSTIC PRE-HEATERS**

***Stasuk Testing & Inspection Ltd.***

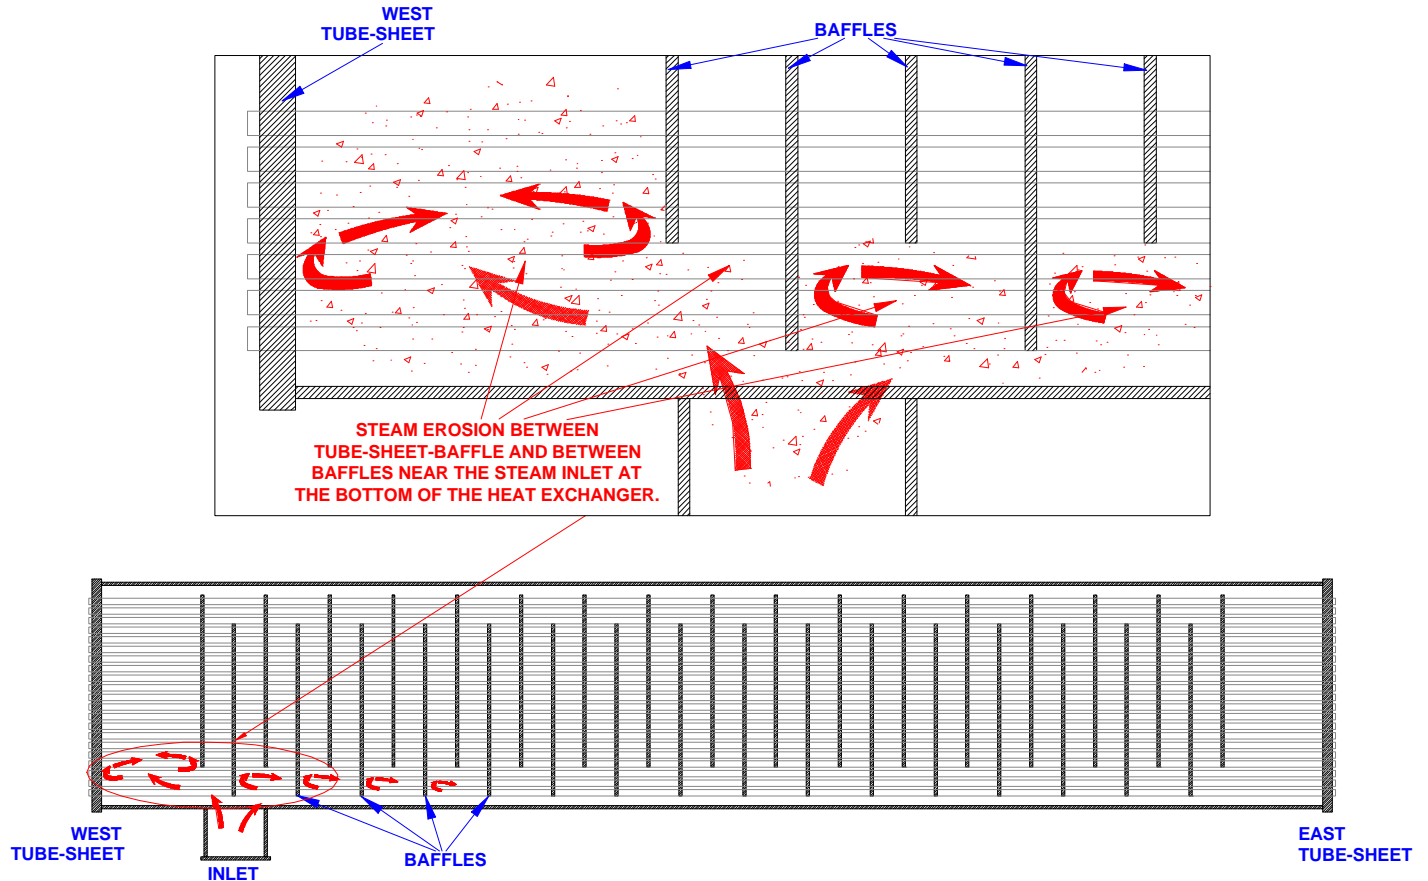
## Visualisation of Areas of Concern/Thinning

From the WIP inspection of the sample of heat exchanger tubes inspected, we can conclude that the tube thinning is occurring in the bottom pre-heater (see sketch on tube thinning visualisation).

The area of concern or thinning is near the steam inlet at the bottom of the bottom/lower pre-heater. The sketch on tube thinning visualisation shows how the steam is probably "swivelling around" and eroding the tubes between the West tube-sheet and the first baffle and between the neighbouring baffles as shown in the sketch.

The tube thinning diminishes away from the steam inlet in the bottom pre-heater. Also, the top pre-heater does not seem to have any significant tube thinning – even at the inlet.

Showing the areas where significant tube thinning is occurring for the bottom heat exchanger.

We recommend that you carry out a full inspection in the heat exchangers during the next outage given the findings of this inspection. This would enable us to give you a full visualisation of the condition of the tubes in the heat exchangers.

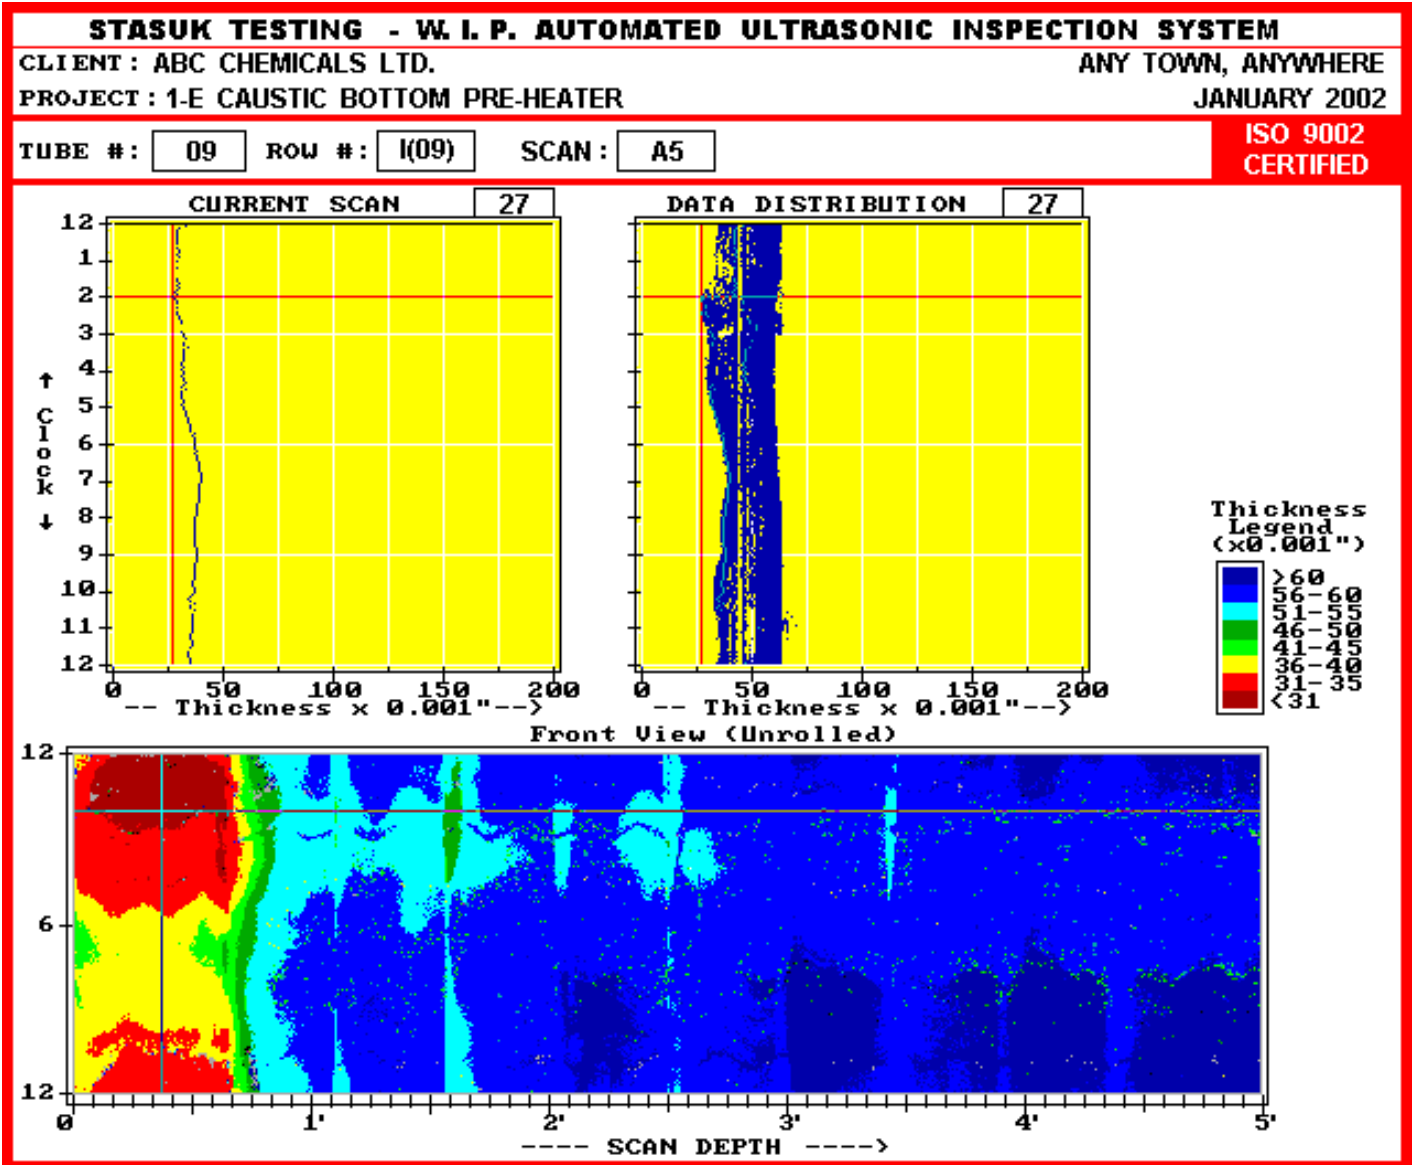
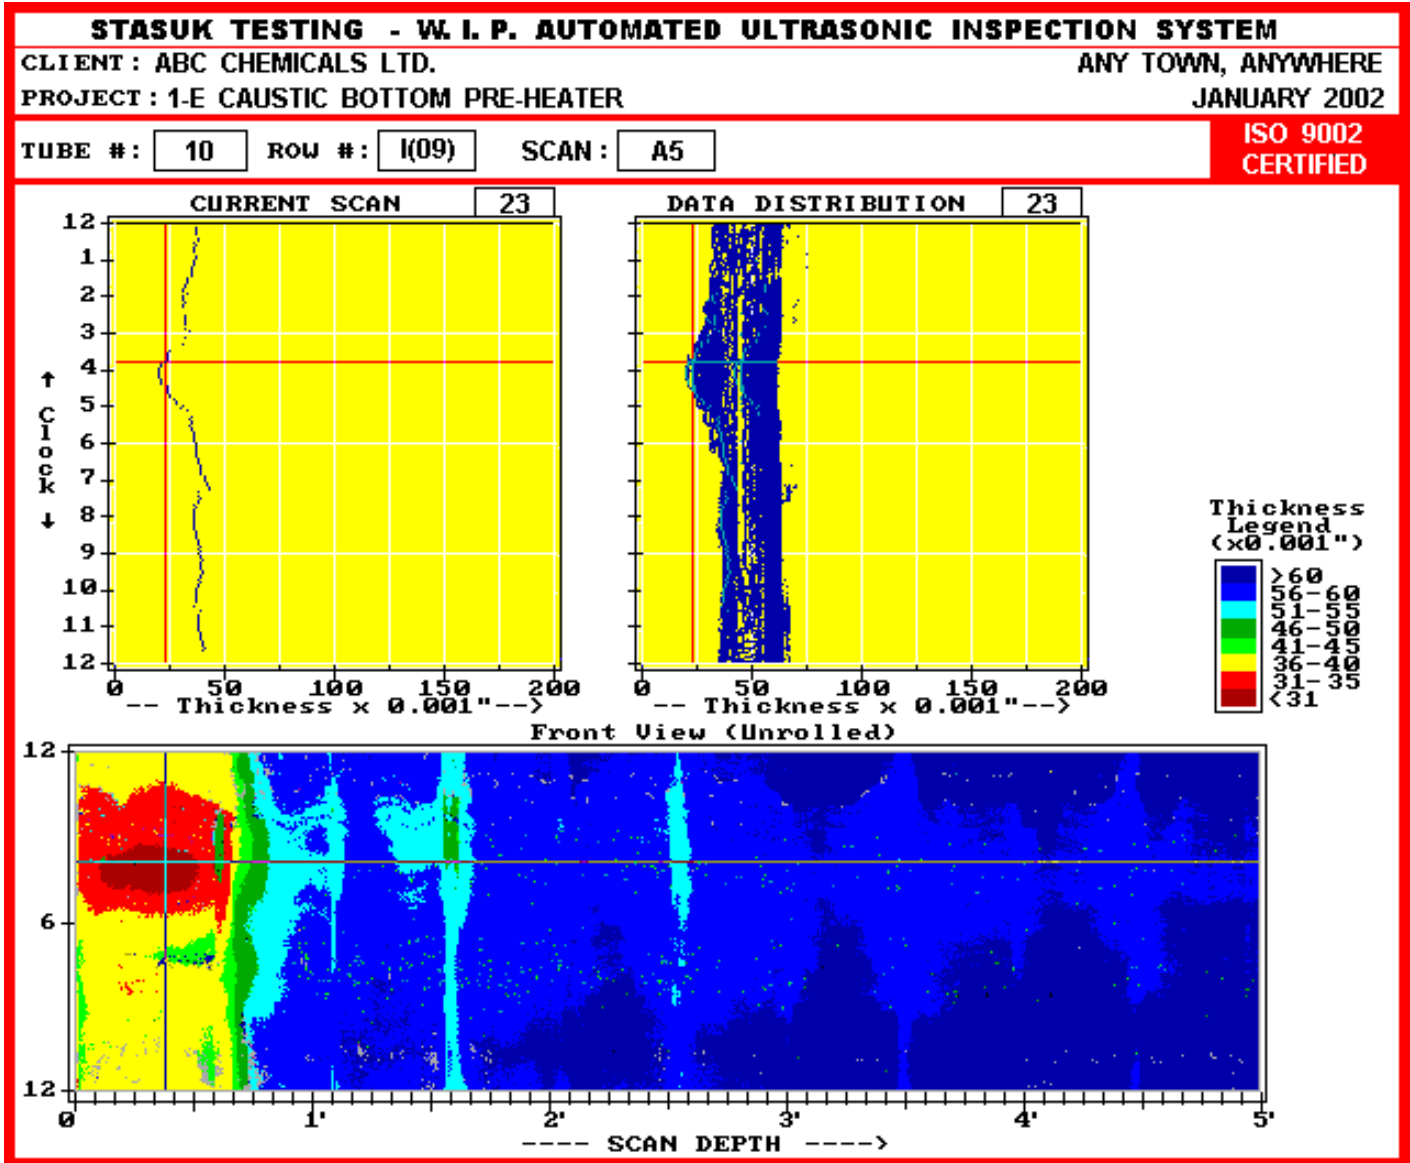
As indicated in the WIP sample images attached – T09RI Scan A, T10RI Scan A and T11RG Scan A – show the main thinning between the West tube-sheet and the first baffle. There is also significant tube thinning in the area(s) between the neighbouring baffles.
