ABC PULP & PAPER COMPANY
ANY TOWN, ANYWHERE

REPORT of NON-DESTRUCTIVE INSPECTION
W. I. P. INSPECTION OF GENERATING BANK TUBES
POWER BOILER

MAY 2002

Re : Final Report on W. I. P. Ultrasonic Inspection of Power Boiler Generating Bank (full-length Mud Drum to Steam Drum) Tubes - May 2002.

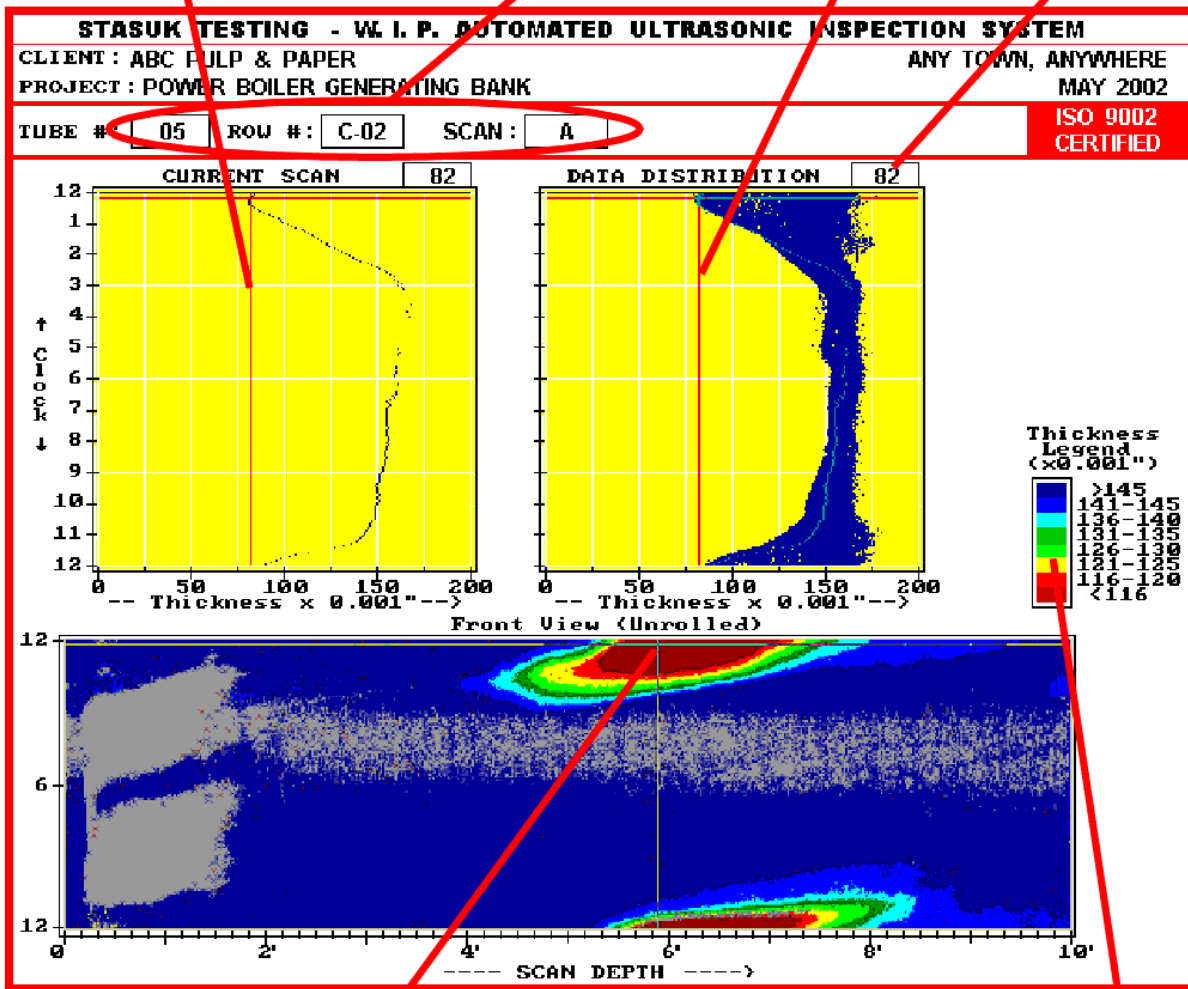
B-scan (End View) showing the single scan where the lowest readings was found.

Tube identification and scan number. Eg. Row C-02 is Cold Side Row 2 & Scan "A" is the first scan from mud drum.

Lowest valid reading found.

C-scan (3-D) display showing the tube thickness profile in color, assuming the tube is rolled and flattened out. The vertical axis represent the circumferential axis and the horizontal represents the axial length of the tube. The cross hair or cursor indicates the lowest valid reading. There is a total of 120,000 possible readings (200 circ. x 600 linear).
